**REPORT OF INVESTIGATION
INTO FATAL INCIDENT
ON LOUGH CORRIB
NEAR ANNAGHDOWN,
CO GALWAY
ON
19th MARCH 2012**

**REPORT No. MCIB/213
(No.14 of 2012)**

Report MCIB/213 published by The Marine Casualty Investigation Board
Printed 10th December 2012.

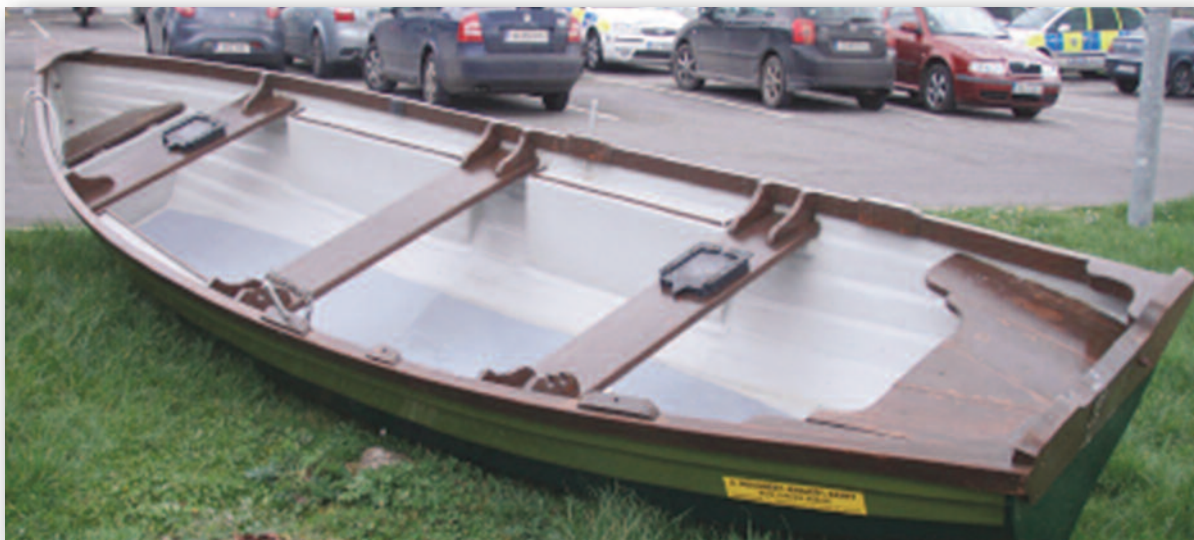
- 4.1.2 In addition to wooden transverse thwarts most of the boats have revolving seats mounted on the thwarts - these seats can be removed. The boat in use had two such seats one on the forward thwart and on the second from aft thwart. These seats were both slightly offset to starboard and did not have a locking mechanism and are always free to revolve.

Photo 1: The boat - note two mounts for revolving seats.

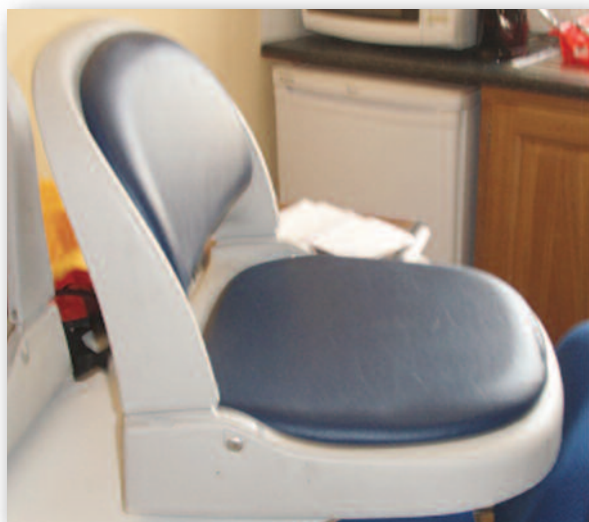
- 4.3 Weight distribution and boat handling will have an effect on a boats performance whatever the category. The swivel seat that Mr Coyle was sitting in was on the forward thwart and mounted slightly to starboard - see Appendix 7.2 (Photos 1 & 2). Whilst it may not have had a detrimental effect on stability whilst fishing when the boat was under way other factors would come into play.

- 4.3.1 The position in the bow, the narrowest part of the boat would not be the best place to sit when the boat heels.
 - 4.3.2 The seat was offset to starboard which was the direction the boat heeled.

- 4.3.3 The momentum of the person sitting in the seat would rotate them sideways in the direction of heel, in this case to starboard.
 - 4.3.4 The net result was that the person in the swivel seat was situated above and close to the starboard gunwale on an unstable platform so when the boat heeled he was easily thrown into the water.

Photo 2: Revolving seat.

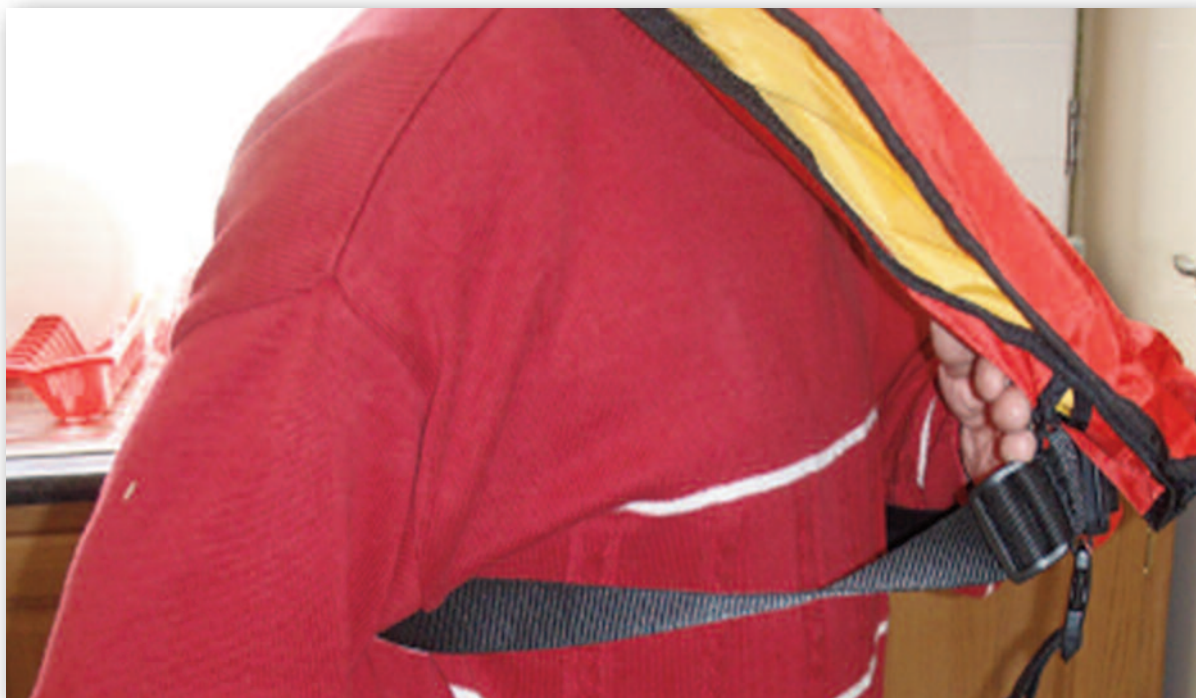
- 4.6 Inspection of the life jackets found them both in good condition, and they both inflated correctly during the incident. Mr Coyle's had no crotch strap and the crotch strap on Mr Ruane's was not secured when it was recovered. As Mr Ruane's lifejacket came off after immersion, therefore it is not unreasonable to assume that it was not fastened between his legs when he was thrown into the water.

- 4.7 The waist straps on both jackets, when inspected subsequently, appeared not to have been adjusted and were expanded to full extent. On Mr Coyle's this was a circumference of 132cm (52 inches) and on Mr Ruane's 137cm (54 inches). Mr Coyle's chest measurement was about 118cm (44 inches) and Mr Ruane's was similar. This would leave about a 25cm (10 inches) slackness of the waist strap in relation to the chest. Appendix 7.2 (see Photo 3). The buoyancy of the jacket would pull the waist strap up over the chest, even with the extra clothing the men were wearing. The wearing of a lifejacket or PFD is mandatory for occupants of vessels of less than 7 meters LOA, the legislation does not cover the correct or incorrect wearing of such a lifejacket or PFD.

Photo 3: Mr Ruane's Lifejacket - note lack of adjustment of waist strap.
