**REPORT OF THE INVESTIGATION
INTO AN EXPLOSION AND FIRE
ON BOARD THE BOAT
'PEGASUS'
OFF ORANMORE STRAND,
CO GALWAY,
ON
9th APRIL 2016**

**REPORT NO. MCIB/256
(No.7 OF 2016)**

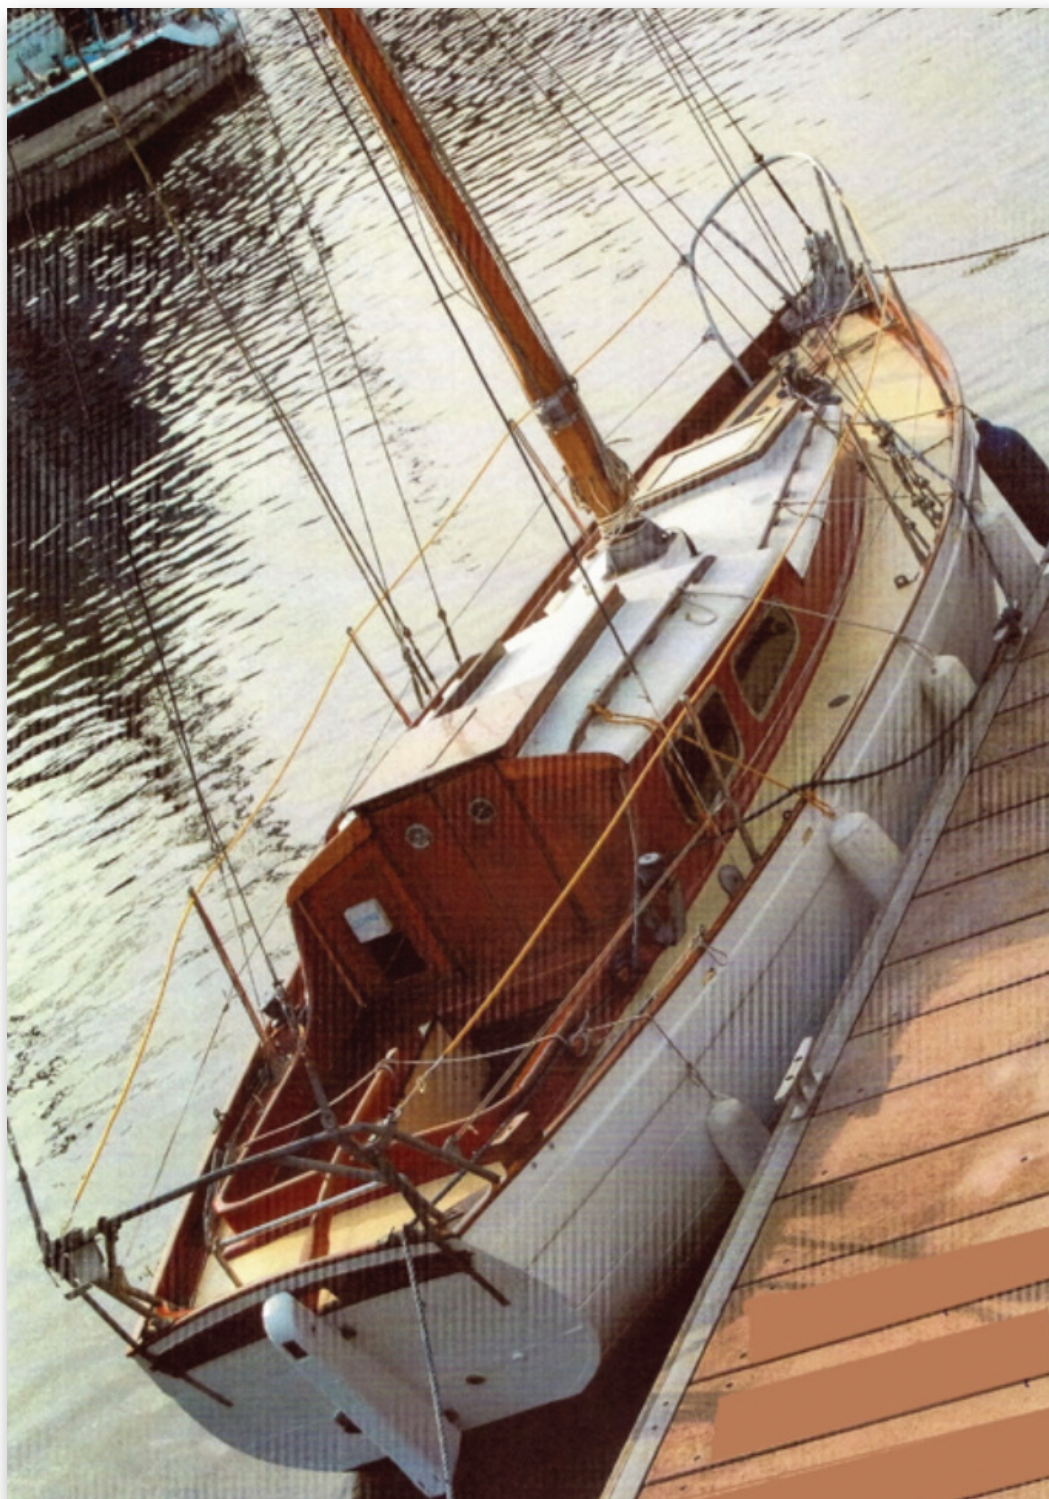
Name of vessel:	<i>'Pegasus'</i> .
Class of vessel:	Virtue 25.
Date of manufacture:	Early 1960's.
LOA:	7.7 metres (m) (25.4').
LWL:	6.6 m (21.6').
Beam:	2.2 m (7.2').
Draft:	1.4 m (4.5').
Displacement:	4.35 tonnes (t).
Construction:	Carvel built mahogany hull planking on oak frames. Marine ply deck sheeted in epoxy. Long keel. Transom hung rudder (see Appendix 7.1 Photograph No. 1).
Engine:	Yanmar 2GM 18 hp with fixed three blade bronze propeller.

Photograph No.1 - 'Pegasus' before the explosion.

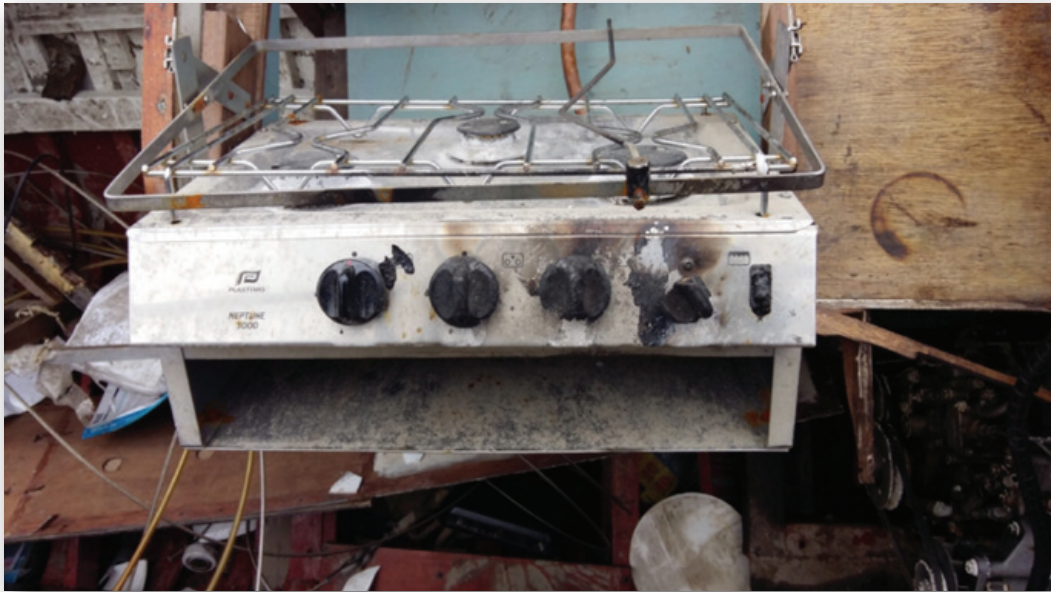
2.5 The vessel was bought by the current owner in 1992 and initially restored professionally in Askeaton, Co. Limerick. A new three burner gas cooker complete with grill was purchased and installed by the owner shortly before the incident (see Appendix 7.1 Photograph No. 2). The installation had been tested but not used.

Photograph No.2 - Cooker as installed in galley.

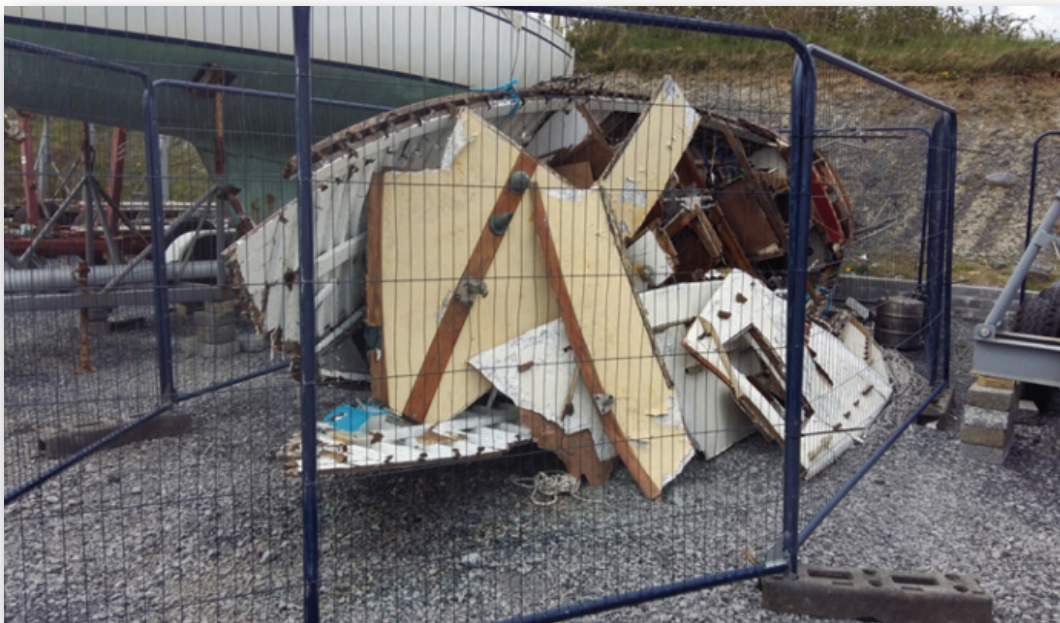
- 3.8 The deck had been blown off the boat, the bulkheads in the cabin had been dislodged and the bow split open by the force of the explosion.

- 3.9 Apart from the owner's burnt hands and his friend's cut head, both men were relatively uninjured and managed to get out of the boat and into the dinghy tied alongside. They released the dinghy and made for the shore.
- 3.10 Meanwhile, a number of people ashore witnessed the incident and two or three launched their own dinghies in an effort to offer assistance. Both men were transferred into the boats of these assistants and taken ashore in the vicinity of Galway Bay Sailing Club where they were taken by ambulance to hospital.
- 3.11 Shortly after the men had abandoned the boat, the '*Pegasus*' sank quickly.
- 3.12 The wreckage of the '*Pegasus*' was raised a week after the incident and brought ashore (see Appendix 7.1 Photograph No. 3).

Photograph No.3 --- following salvage.

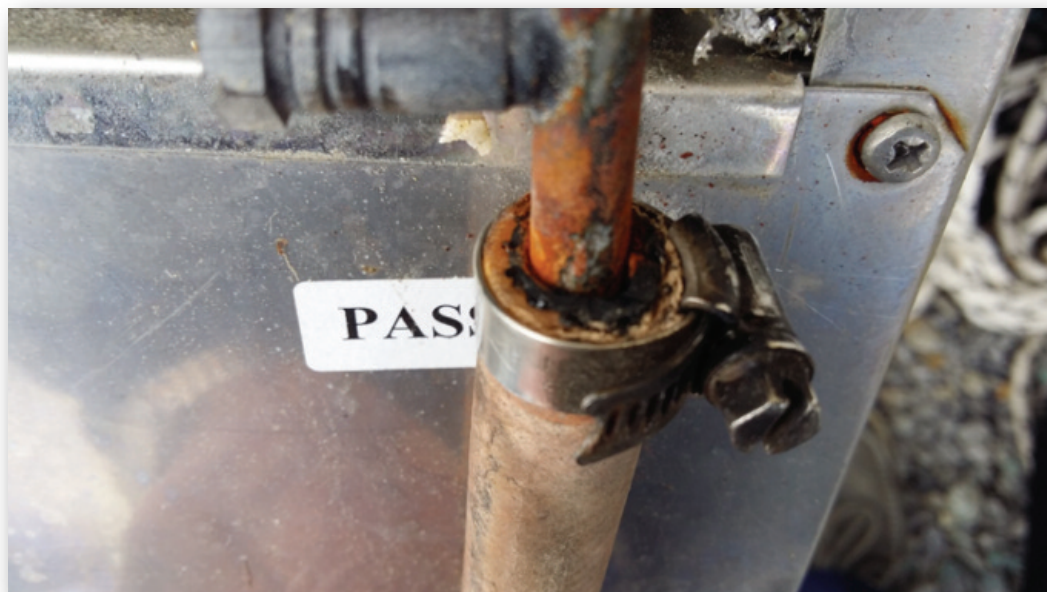
- 4.1 The gas cylinder in use at the time of the incident was a Campingaz type cylinder with a screw on regulator mounted on top. The regulator was equipped with an isolating valve. The cylinder and regulator could not be found following the incident. The owner had installed the new cooker in gimbals on the starboard side of the cabin in the galley area. The flexible hose was routed from the cockpit into the cabin and emerged outboard from the cooker. The hose was then fitted to the copper hose tail on the cooker and secured with a hose clamp (see Appendix 7.1 Photograph No. 4). No secondary isolating valve was fitted nor was a gas alarm.

Photograph No.4 - Gas hose refitted to cooker hose tail.

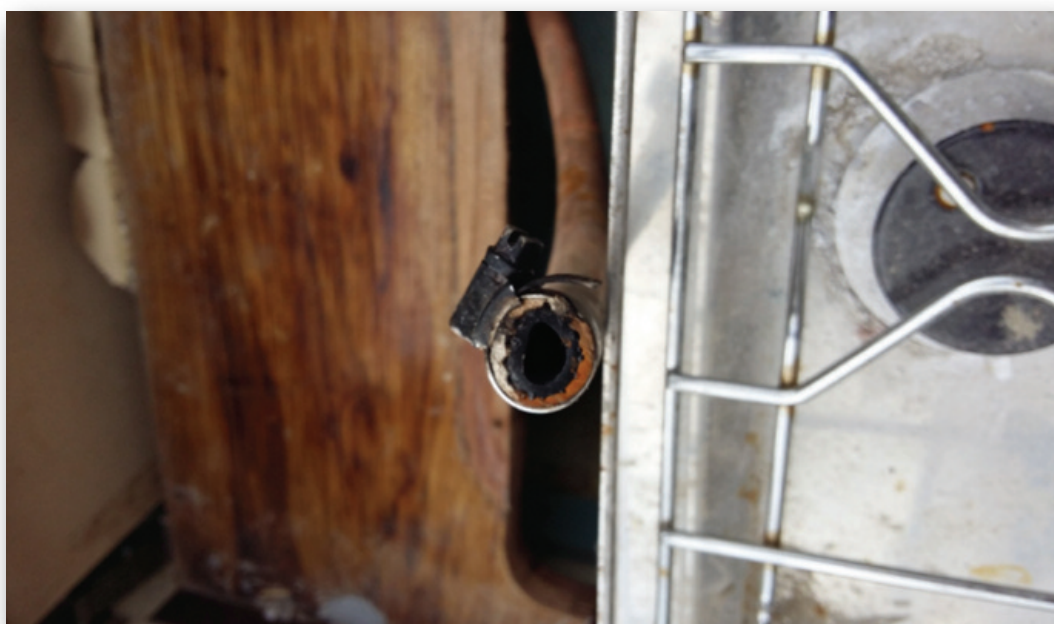
- 4.2 The flexible hose used for the gas installation was of an approved type however, the internal diameter was too large for the outside diameter of the cooker hose tail. The result of this was that, despite being clamped in place by the hose clamp, the hose was likely to have been loose and its shape distorted. The initial inspection of the gas installation following recovery of the vessel showed that the hose had become disconnected from the cooker hose tail. The end of the hose and the hose clamp were found to be distorted and also blackened and scorched (see Appendix 7.1 Photograph No. 5).

- 4.3 It was noted that there was a ball of blue flame. The nature of this would suggest that it is most likely caused by the ignition of gas which had collected in the bilges of the vessel as a result of the hose becoming loose at the connection to the cooker. As the valve was open at the cylinder this would have released gas for the period of the ten minutes that it was open.

- 5.1 As the explosion caused severe and extensive damage to the vessel, it is not possible to be certain of the layout of the gas cylinder, regulator and hose prior to the explosion, however; as the gas hose was detached from the cooker hose tail and blackened and scorched on inspection, it is most likely that it had become loose or partially detached before the incident took place. Thus, when the gas valve was turned on in the cockpit, it is most likely that gas was flowing freely into the grill area of the cooker and, as this gas is denser than air, overflowing onto the floor and then into the bilges. When the owner struck the match, the gas on the floor and in the bilge exploded and the gas flowing from the hose ignited forming a blue ball of flame.

Photograph No.5 - Gas hose cooker end as found, charred and distorted.

- 5.2 If a gas alarm had been installed, it would have sounded as soon as the gas started flowing from the hose and given adequate warning of a gas leak. This would have alerted the owner and could have prevented the events which followed.

- 6.1 It is recommended that the Minister for Transport, Tourism and Sport draws attention to Marine Notice No 1 of 2002 - Use of liquefied petroleum gas (LPG) installations and systems on merchant vessels, fishing vessels, pleasure craft and other marine craft.
- 6.2 It is recommended that the Minister for Transport, Tourism and Sport should provide updated guidance on the fitting and usage of LPG installations in the Code of Practice for the Safe Operation of Recreational Craft. This is included as Action No. 16 in the Maritime Safety Strategy of the Department of Transport, Tourism and Sport.
