**REPORT OF INVESTIGATION
INTO INCIDENT AT
DONEGAL POINT,
KILKEE, CO.CLARE
ON
5th NOVEMBER 2011**

**REPORT No. MCIB/208
(No.12 of 2012)**

Report MCIB/208 published by The Marine Casualty Investigation Board
Printed 4th November 2012.

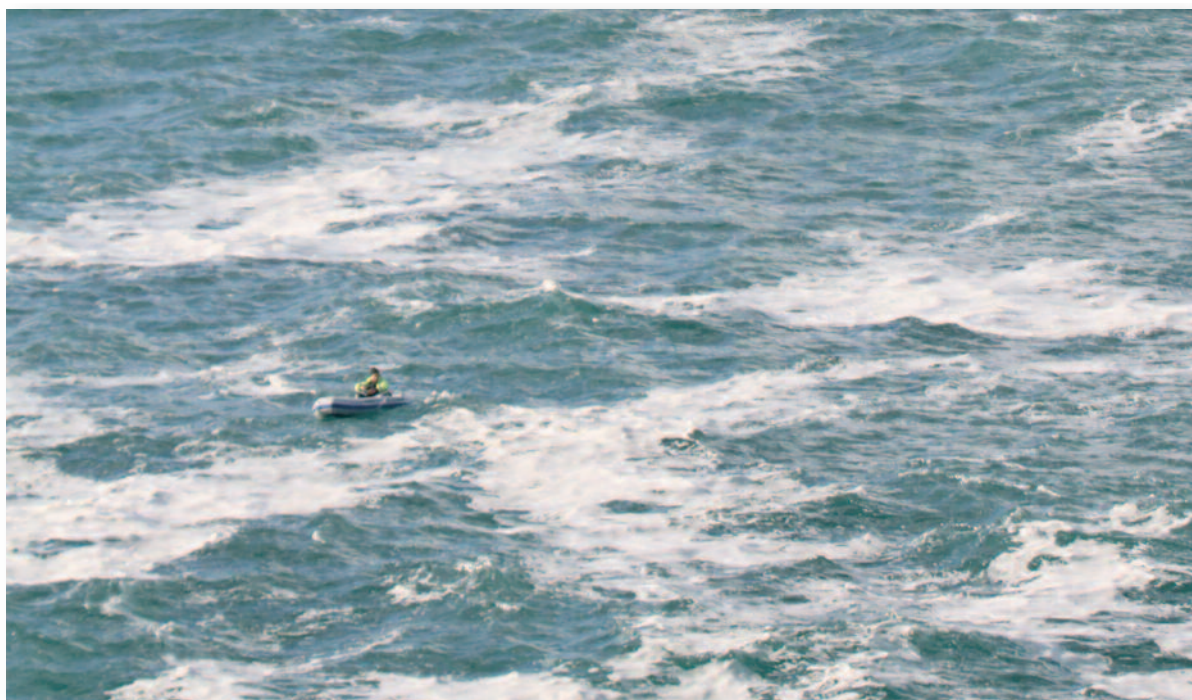
(a) Initial sighting of Mr. Silins in dinghy

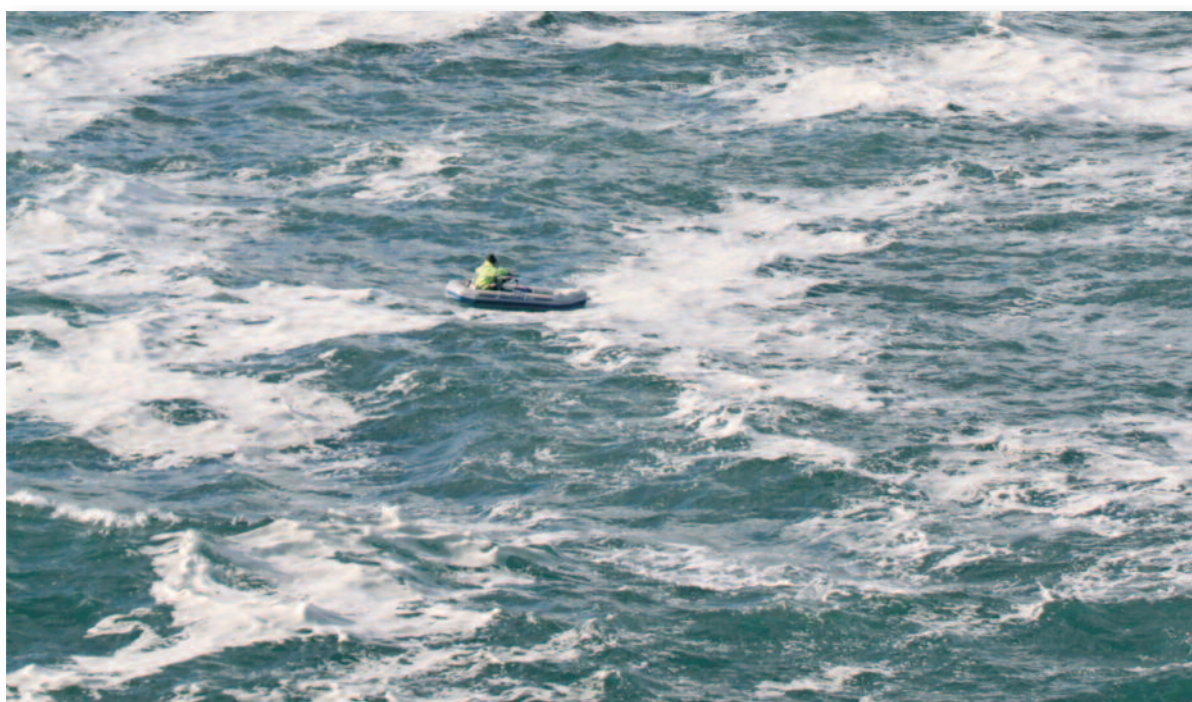
(b) Subsequent sighting of Mr. Silins in dinghy

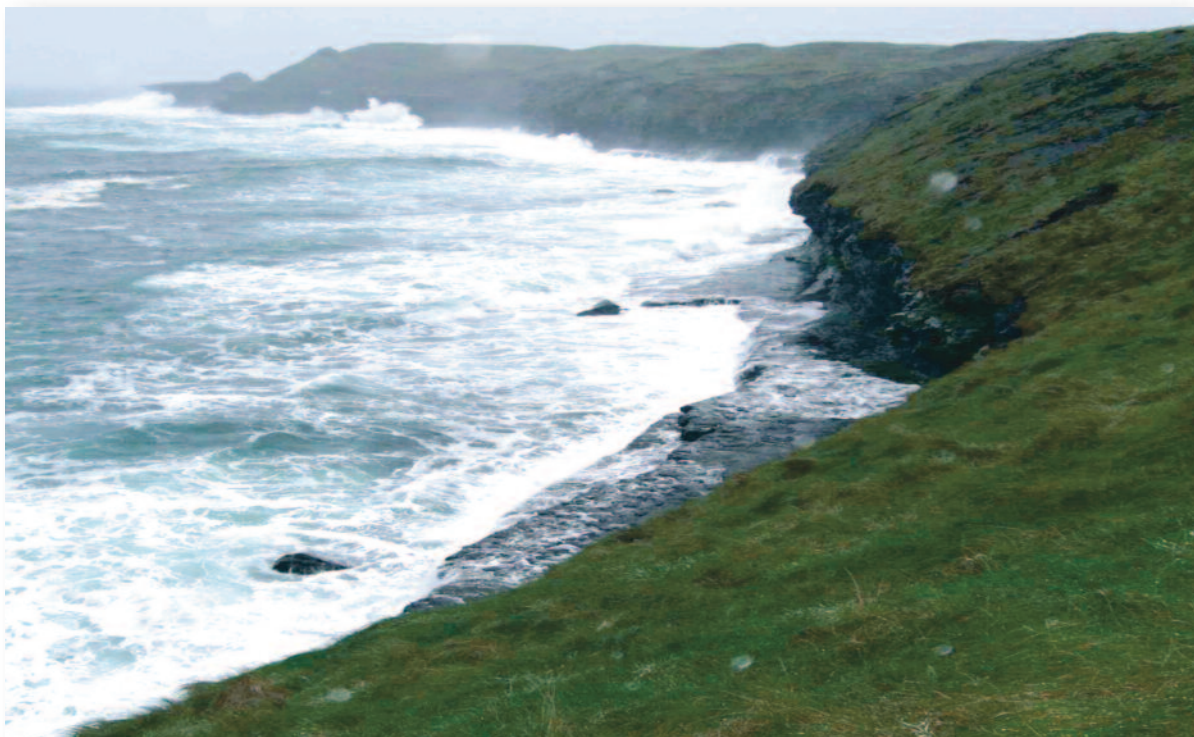
(c) View of inner sweep of northern side of the "Horseshoe"

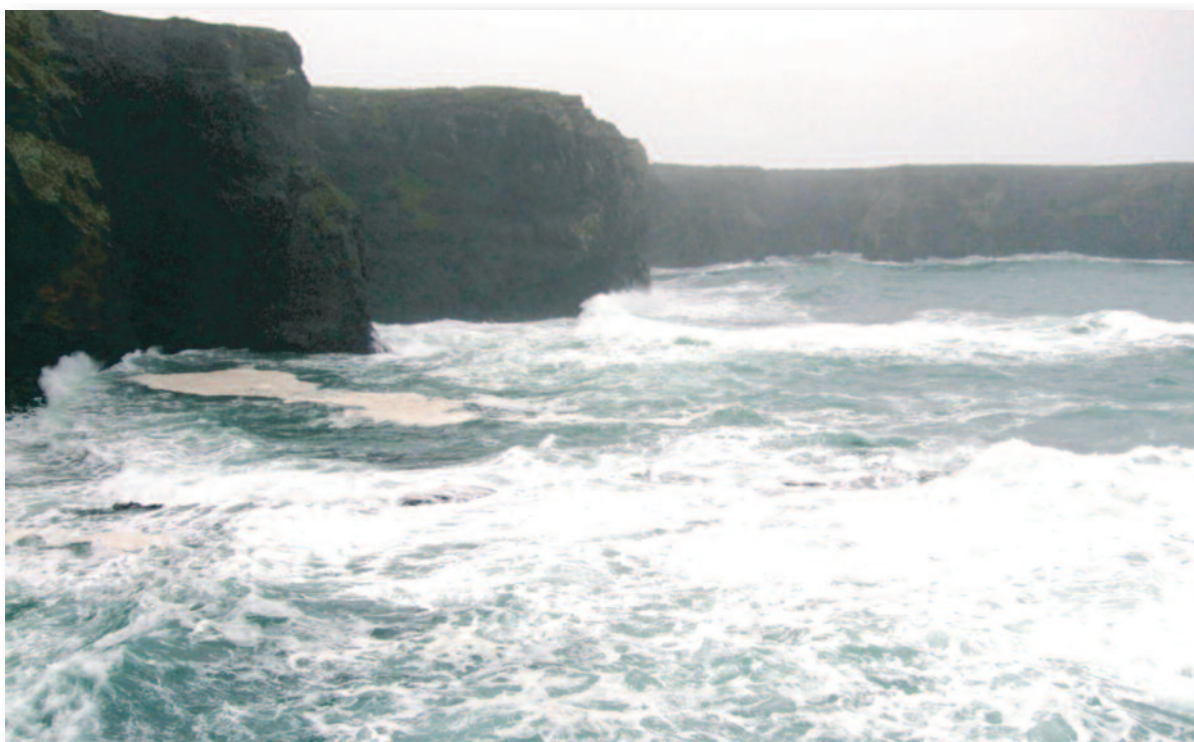
(d) Inner sweep of southern side - exposed rocks and breaking swell

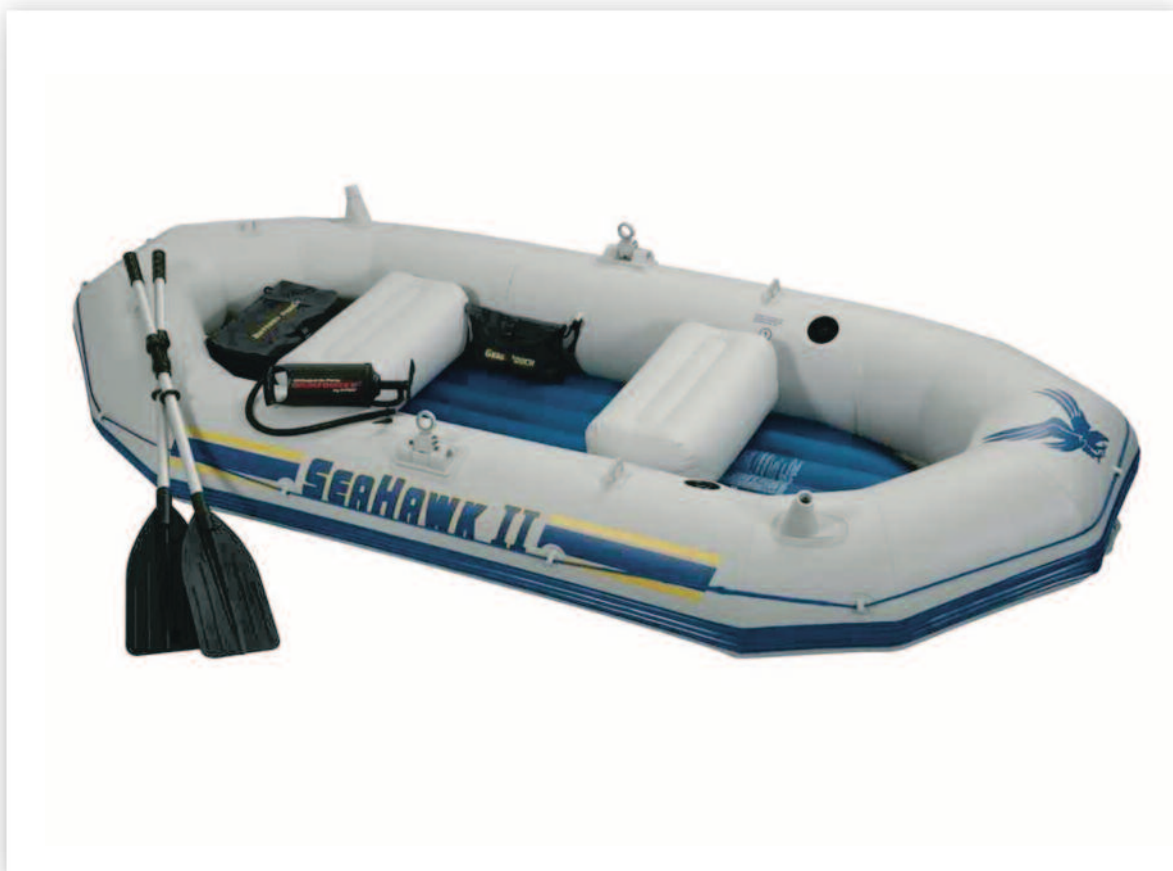
Appendix 7.3 Illustration of inflatable dinghy - SeaHawk 11.

In addition, as observed from the shore, it would appear that he was unaware of the appropriate drill/procedure to right the dinghy following capsize. The Investigation notes that the dinghy was set about with a becketted line which could have been used for this purpose.

The manufacturers of the dinghy class it as a one engine three-person craft. In this instance with only a single occupant and in the prevailing swell conditions, the craft would have been vulnerable to capsize in a beam sea/breaking swell.

In the context of capsize of an inflatable - be familiar with the method of righting the craft in the water by standing in the beackets on one side and heaving on the beackets on the opposite side.

In the case of an inflatable with external hand grips fitted externally to the bow and stern, the fitting of a strop secured to each hand grip and run fore and aft under the craft would greatly assist a lone person to right the craft in the event of capsize.
