**REPORT INTO THE SINKING OF
FV “*LADY EILEEN*”
ON
13th AUGUST 2012**

**REPORT No. MCIB/223
(No.8 of 2013)**

Report MCIB/223 published by The Marine Casualty Investigation Board
Printed 24th May 2013.

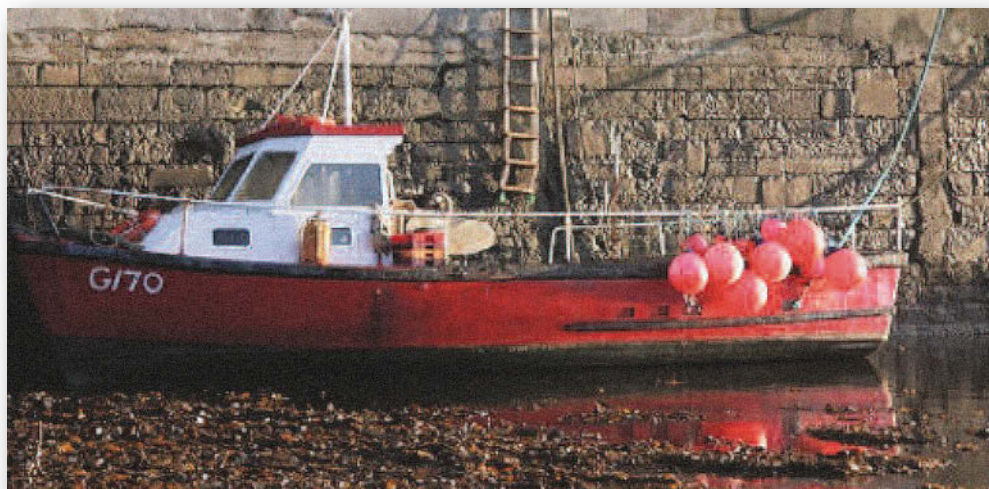
General View of the F/V "LADY EILEEN"
