**REPORT ON FATAL INCIDENT
INVOLVING A CAPSIZED BOAT
AT COD'S HEAD,
KENMARE BAY, WEST CORK
ON
13th AUGUST 2012**

**REPORT No. MCIB/222
(No.9 of 2013)**

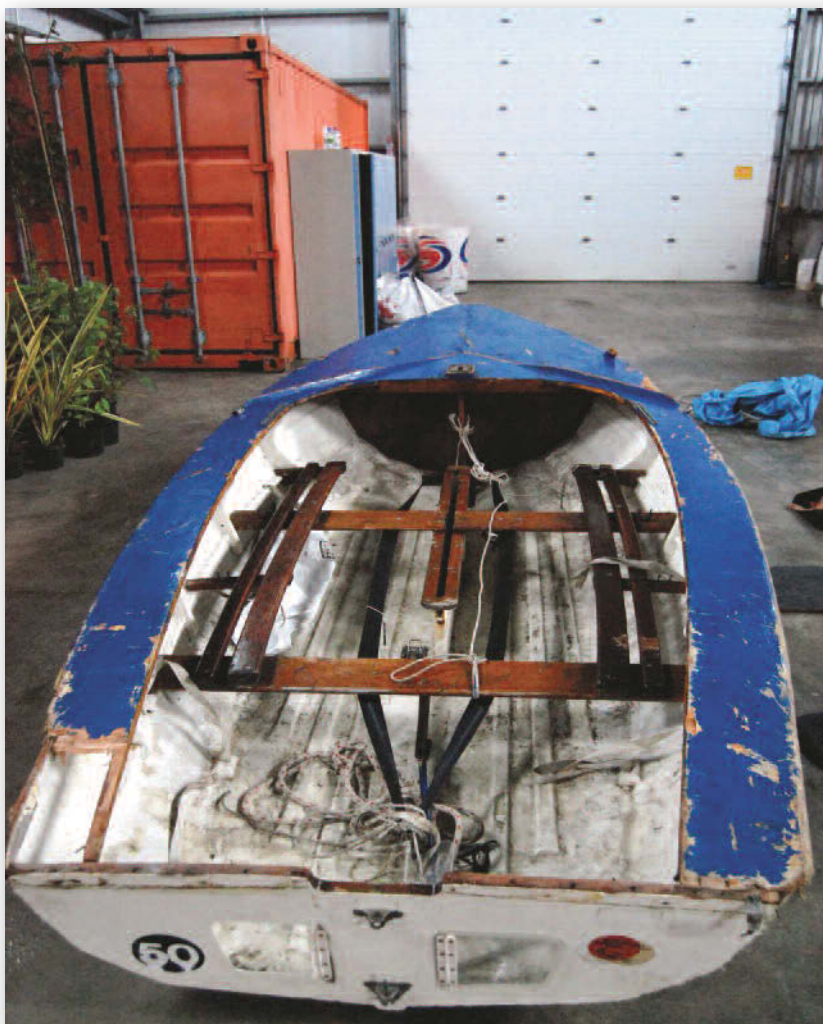
Appendix 7.3 Dinghy at time of inspection in Castletownbere Coast Guard station.

- 4.1 When inspected, the sailing dingy was found to be very badly damaged. However, in interview with both Mr Christy O’Leary and Mr Julian Brown of the Castletownbere Coast Guard, it was determined that the vessel was in good order prior to the incident. Mr Julian Brown went on to explain that the vessel was in good condition at 12:00hrs on Tuesday the 14th when Julian and his colleague Derek Lowes found the upturned vessel wedged in the rocks close to where Christy O’Leary had come ashore.

The night of the 14th and morning of the 15th saw high winds and heavy seas which caused the majority of the damage.

- 4.3 During the vessel inspection it was noted that the forward buoyancy tank and the forward port buoyancy bag were in place. It was confirmed that before departure, the forward starboard buoyancy bag was in place. Mr Julian Brown confirms that, when he righted the boat on the 14th, both the forward buoyancy bags were in place and inflated. It is assumed that the starboard bag was lost during the recovery or during the bad weather the night before the recovery.

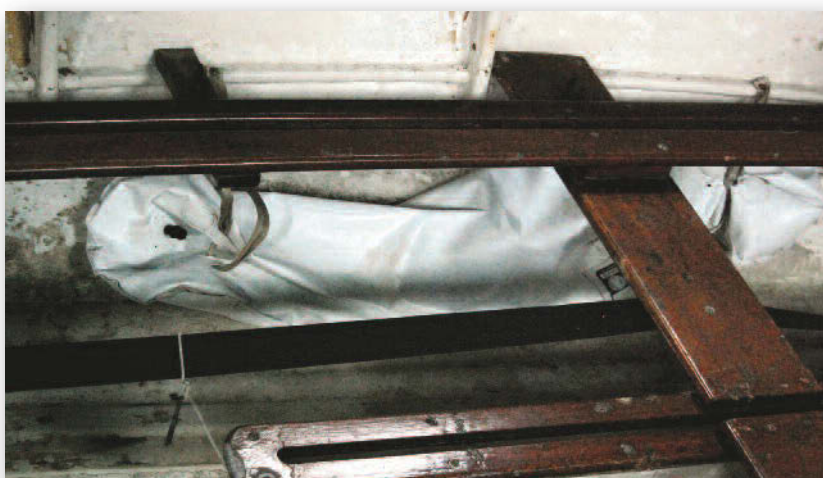
- 5.1 The Enterprise sailing dingy had insufficient buoyancy bags and as a result it did not have passive buoyancy to be bailed out after a capsize.
- 5.2 Mr John O'Leary was an experienced sailor and was used to the Enterprise class.
- 5.3 Before departure Mr John O'Leary did not agree a return time or sailing area with a responsible person ashore. If he had done this, the rescue may have occurred before they decided to enter the water.
- 5.4 Whilst Mr John O'Leary and his son were wearing good life jackets they were not wearing wetsuits. The cold and the stresses from the cold would have impaired their decision making process. This may have led to their discussion to attempt the swim to shore.
- 5.5 The vessel remained afloat after it capsized and did so until it drifted to shore.

The only remaining deflated buoyancy bag.
