**REPORT OF THE INVESTIGATION  
INTO  
AN INCIDENT INVOLVING  
A RIB ON LOUGH REE,  
ATHLONE,  
CO. WESTMEATH  
ON  
14th JULY 2012**

**REPORT NO. MCIB/219  
(No.5 OF 2014)**

Report MCIB/219 published by The Marine Casualty Investigation Board.  
Printed 11th November 2014.

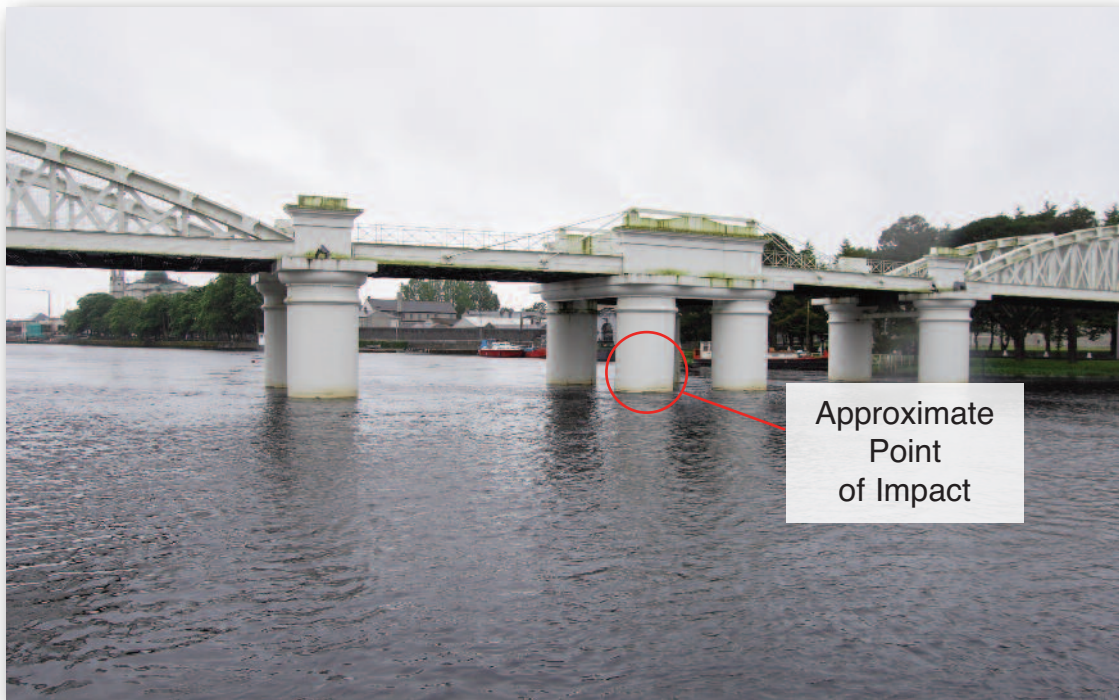
### Appendix 7.3 Photograph of the Athlone Railway Bridge.

- 3.6 A very short time after their departure, the RIB struck one of the centre support pillars of the Athlone Railway Bridge. (See Appendix 7.3 Photograph of Athlone Railway Bridge).

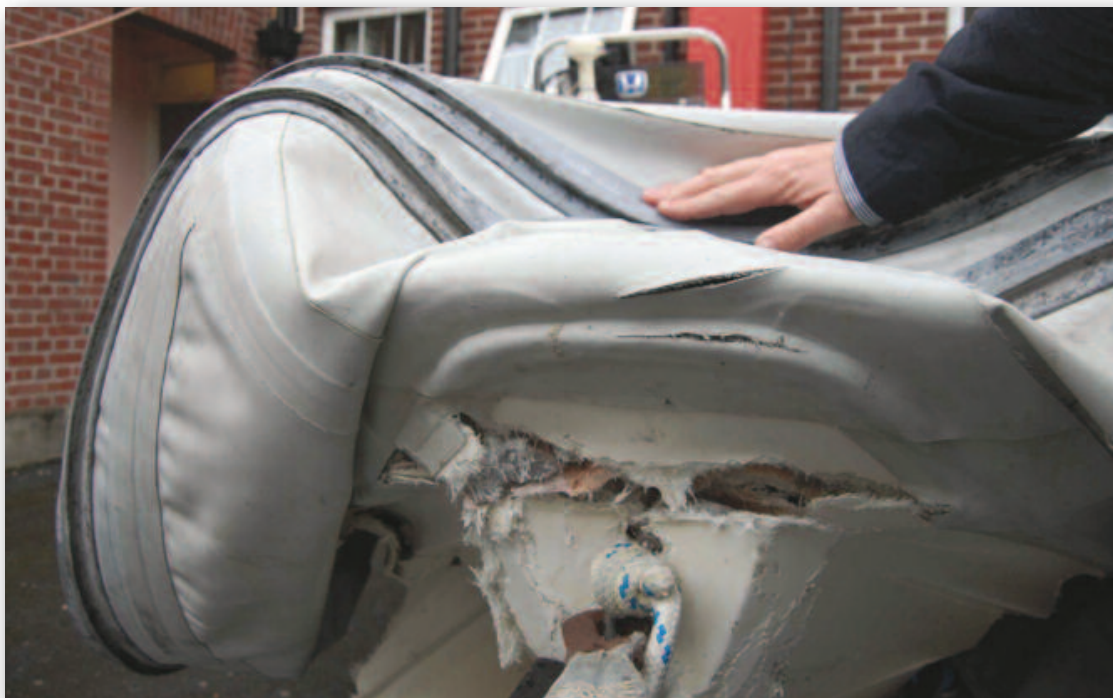
- 4.1 The RIB's sponson is a three-chamber arrangement and upon inspection the forward and port side chambers were deflated. Further investigation found the forward chamber was torn in at least 2 places. These were both on the underside of the tube at the bow. These tears were approximately 80 mm in length, which would have instantly deflated the forward chamber. (See Appendix 7.4 Photograph No. 1).

- 5.1 The collision occurred less than 300 m from the RIB's departure point. Therefore it is likely that the craft was accelerating until very shortly before the collision. This may explain the sponson damage being on the underside of the tube as RIBs tend to sit quite bow up as they accelerate onto the plane.
- 5.2 The extent of damage was consistent with the RIB travelling quickly at speeds of above 15 knots.
- 5.3 The collision occurred at or around sunset. Given the weather that evening, it is likely that the light conditions would not have been good.
- 5.4 Only two of the occupants in the RIB were wearing Personal Flotation Devices (PFDs).
- 5.5 The RIB was in good order prior to the incident and was not a contributory factor to this incident.

Photograph No. 1: Shows two of the tears that caused the forward chamber to deflate

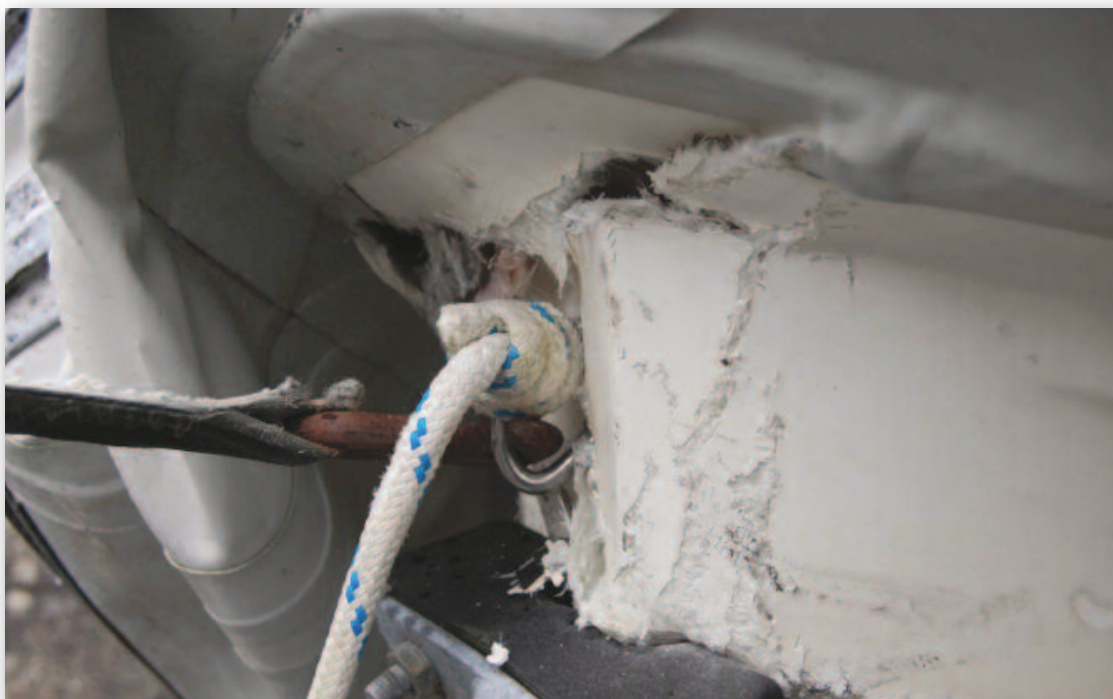
- 4.3 The hull failed in two positions. The first was on the bow stem just below the hull flange, where the sponson meets the GRP hull. The second was about 300 mm aft of the stem, where the chain locker starts. The forward damage was a result of the collision energy being transferred into the GRP hull in this area, causing total failure of the laminate. The painter ring (stainless steel U bolt on the bow of the boat) had been driven back and the glass surrounding had been crushed. About 100 mm aft of the bow tip, the hull laminate was split on both the port and starboard sides, running from stem to the top of the GRP hull. (See Appendix 7.4 Photograph No. 2).

Photograph No. 2: Shows the smashed glass on the stem N.B. the rope is attached to the painter ring

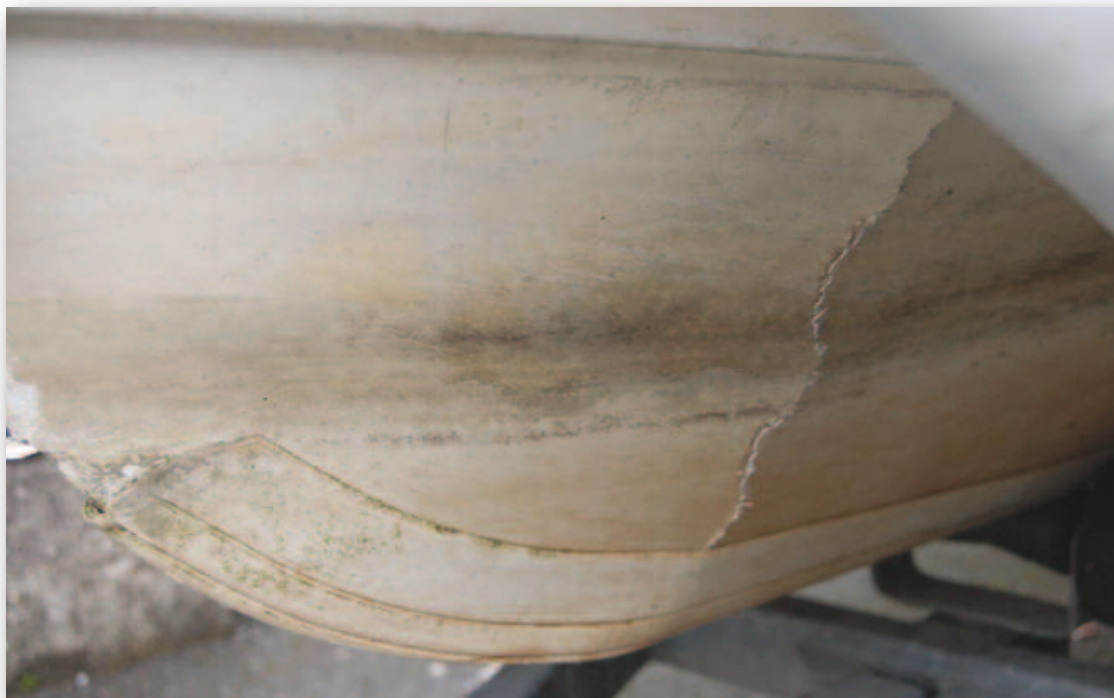
- 4.4 The second damaged area was about 300 mm aft, in this area the hull was split transversely from the keel to the sponson flange. This was caused by the collision energy travelling along the hull laminate until it met the transverse bulkhead that forms the forward part of the chain locker. At this point the bulkhead acted as a stress raiser, spreading the collision energy out board along the bulkhead causing the hull laminate to split on the port side and fold on the starboard side. (See Appendix 7.4 Photographs No. 3 and No. 4).

Photograph No. 3: Split in the hull laminate on the port side

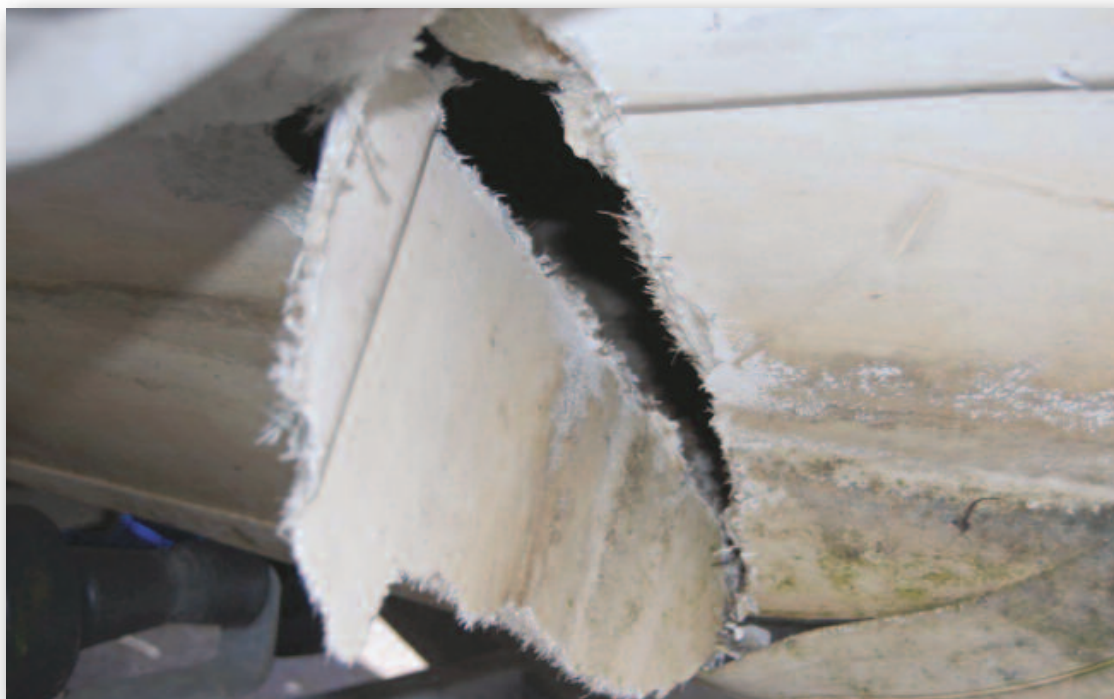
Photograph No. 4: Fold in the hull laminate on the starboard side

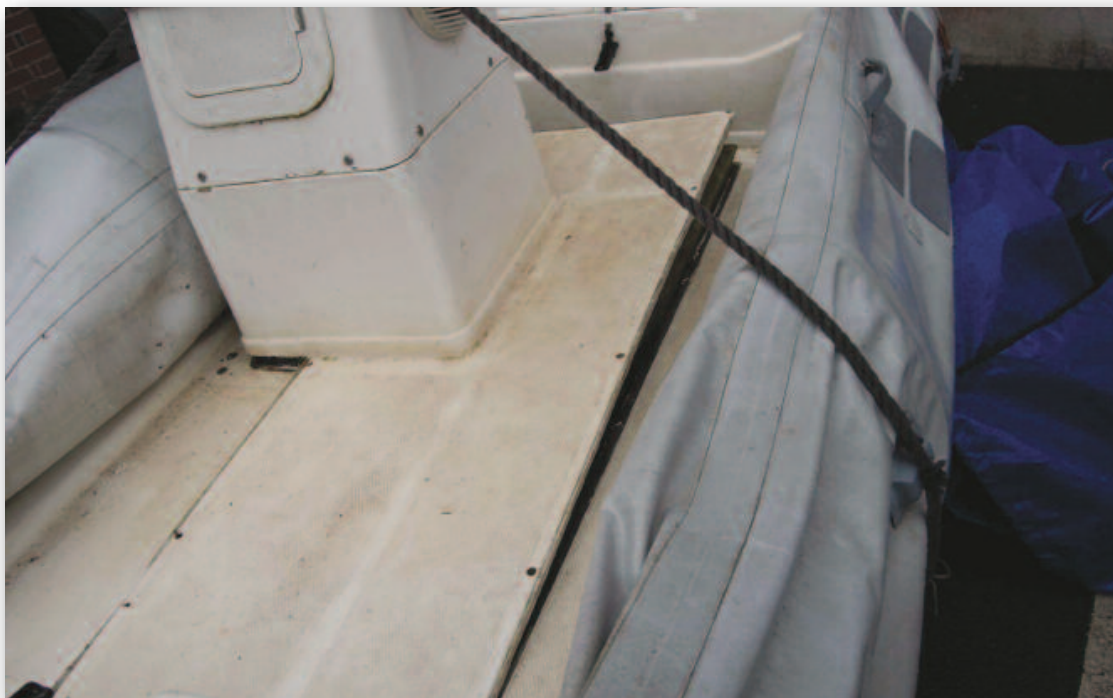
- 4.5 The centre console was fixed to a GRP deck plate that doubles up as a cover for the inboard fuel tank. This cover board was fixed to the rest of the deck by means of stainless steel screws. The aft side of the cover board had lifted and the stainless steel screws were pulled from the deck beams. This damage was most likely due to the force exerted on the console by the momentum of the helmsman. (See Appendix 7.4 Photograph No. 5).

Photograph No. 5: Console and the deck lifted to reveal the inboard fuel tank beneath
