**REPORT OF INVESTIGATION
INTO FATAL INCIDENT
OFF CARRAROE, CO. GALWAY
ON
30th MAY 2010**

**REPORT No. MCIB/187
(No. 01 of 2011)**

Report MCIB/187 published by The Marine Casualty Investigation Board
14th January 2011

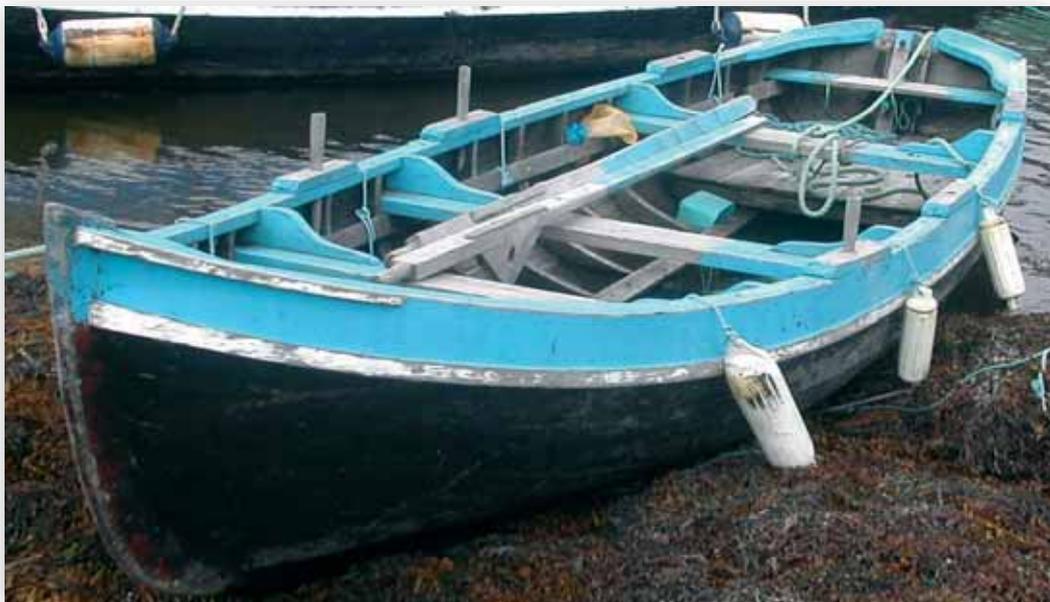
Class of vessel:	Currach
LOA:	18'
Material:	Timber
Engine:	Outboard 15 hp
Owner:	Mr. Pádraig O'Cuailain, Carraroe, Co. Galway

Photograph of Mr. Pádraig O'Cuailain's currach

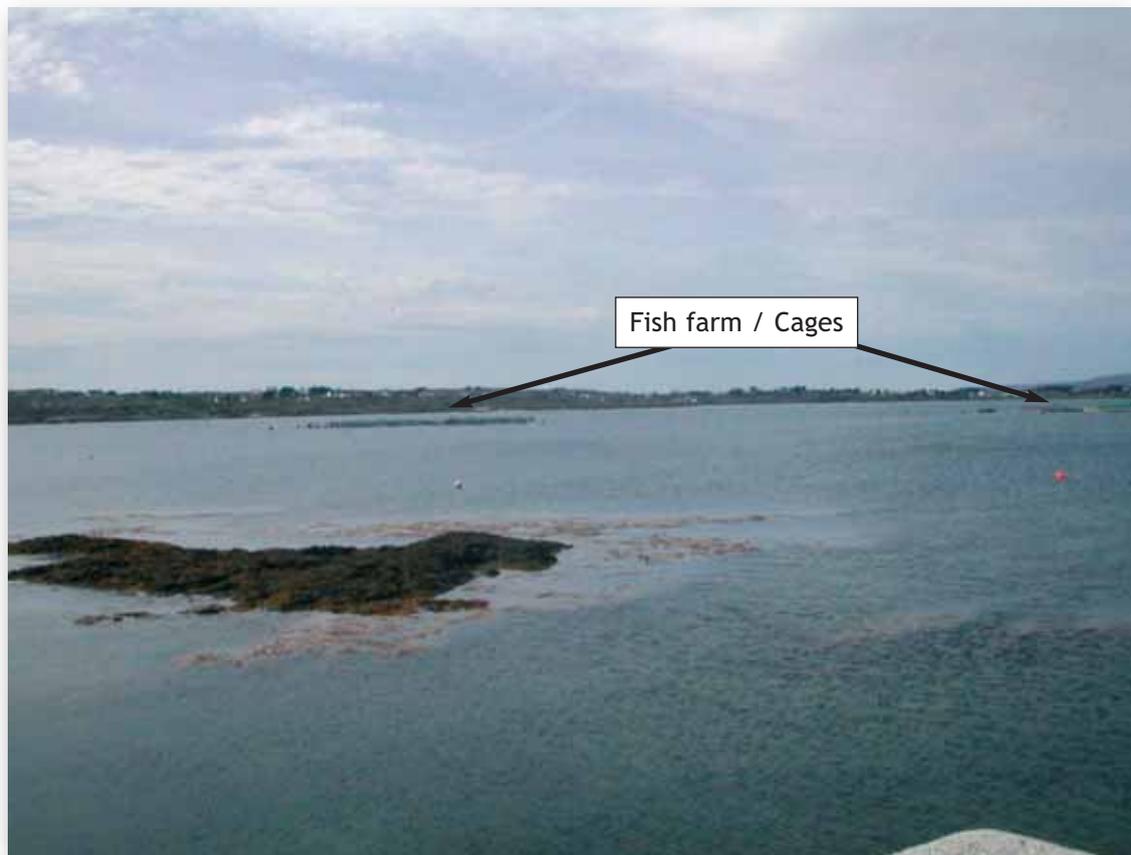
APPENDIX 8.1

Appendix 8.1 View from Chaladh Thaidhg Pier looking west.

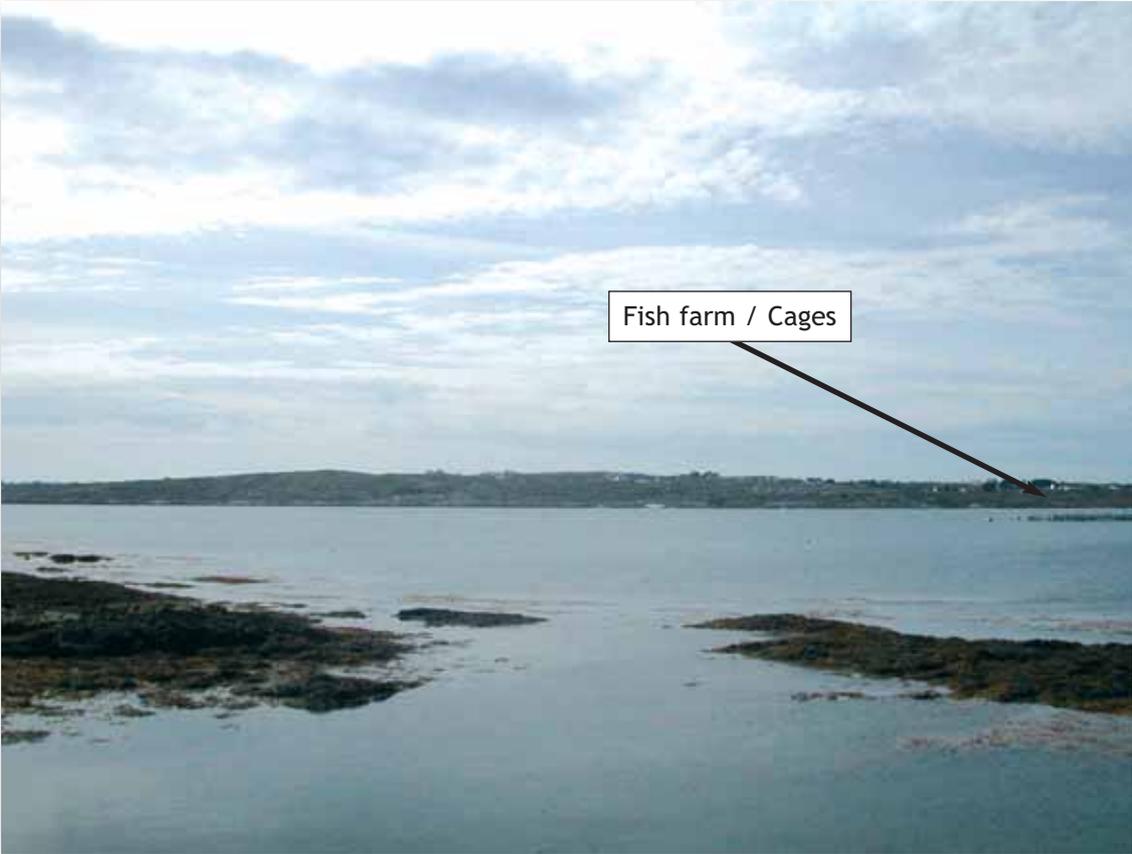
Appendix 8.2 View from Chaladh Thaidhg Pier looking south west.

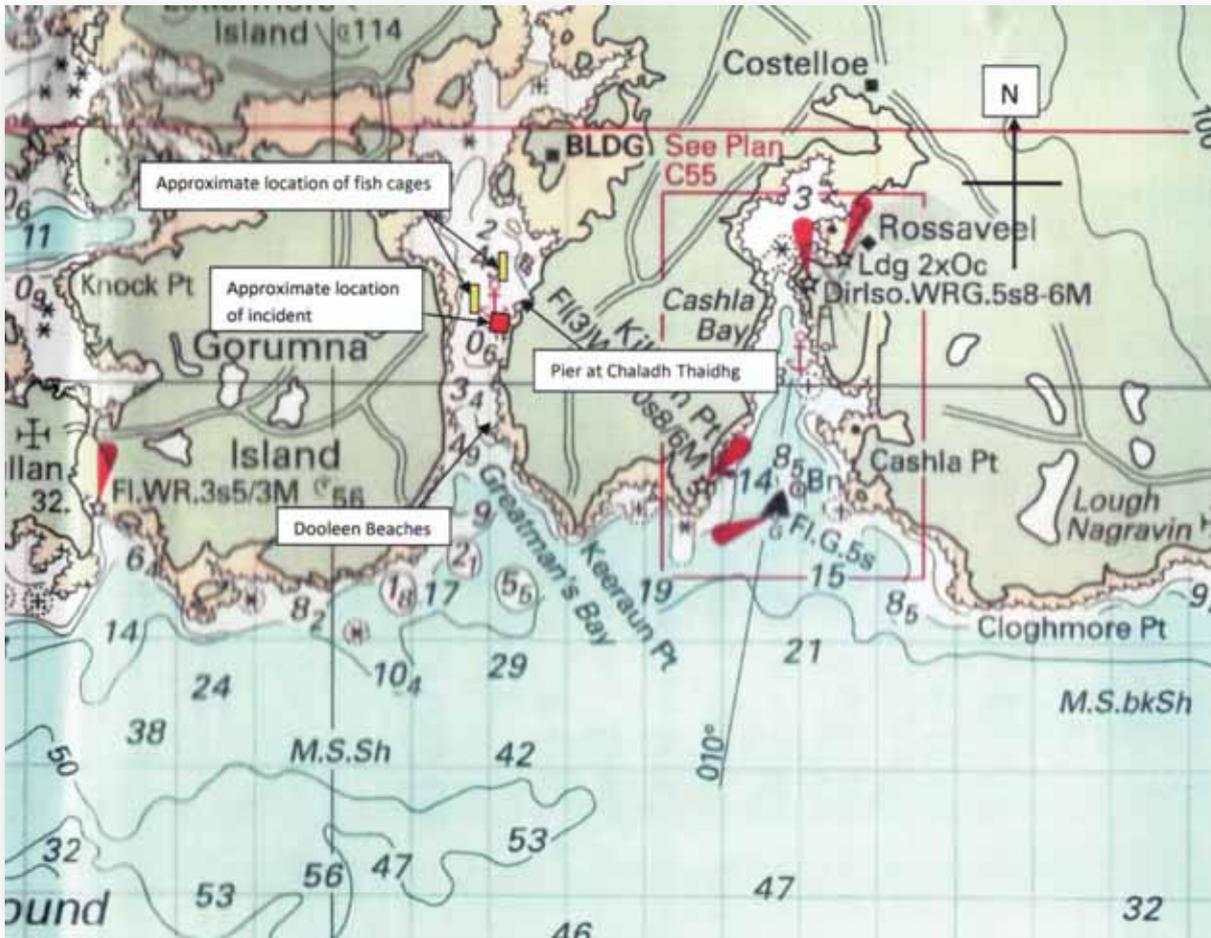
APPENDIX 8.3

Appendix 8.3 Chart extract showing location of incident.
